# Customer Repairs

## Two difficult Marconi repairs

I bought a faulty model 2432A Marconi Frequency Counter some time ago. It was fairly cheap, being described as faulty; and as I'd also picked up a manual for it, I thought it would be a good repair proposition.

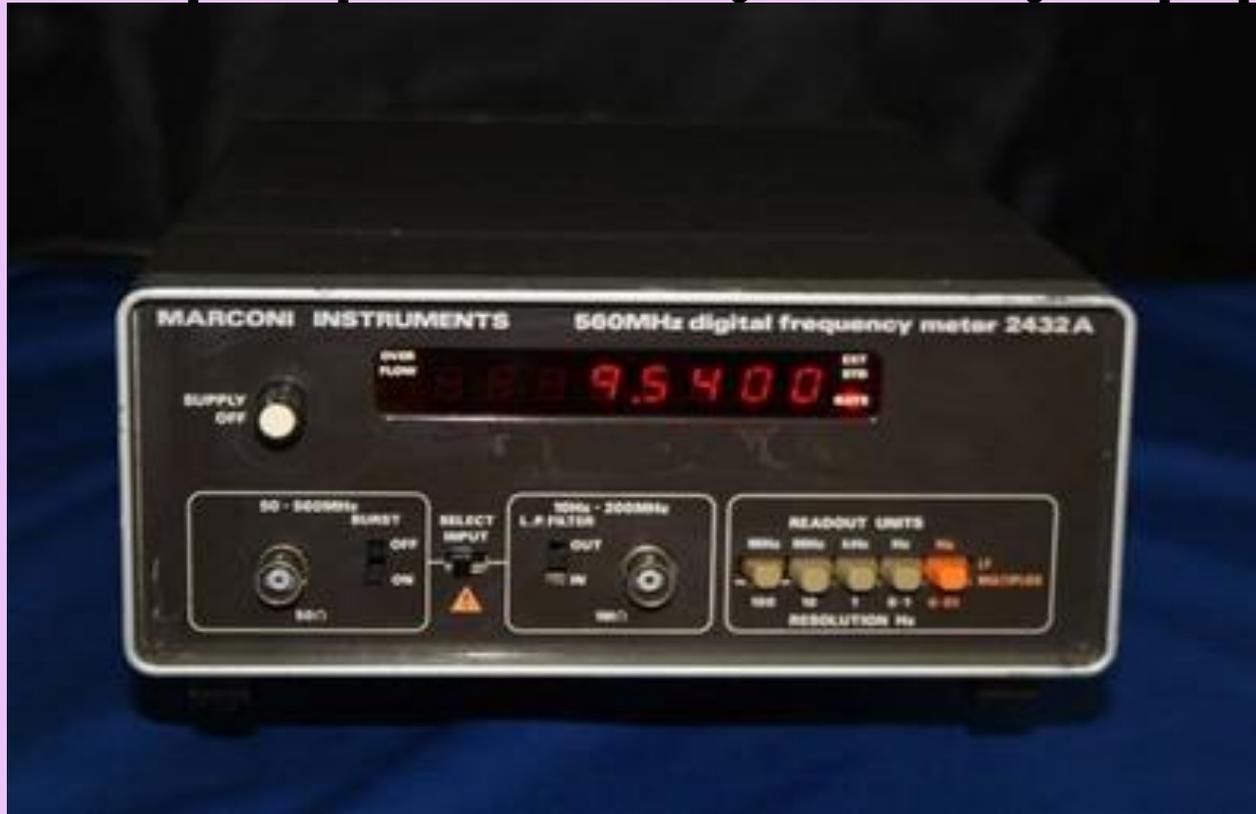
Also, the thing was without its outer case and it had obviously been stored somewhere damp allowing the circuit board to become tatty-looking and the soldering to take on a cloudy look.

The power supply seemed to be faulty. This used a couple of 741 op amps, the connections to which had been really badly damaged, by the last repairer, with missing pads and scruffy bits of wire added.

The second time I'd looked at it I'd replaced the two op amps and tidied up the soldering. I'd also fitted a couple of replacement regulator transistors as these were short-circuit.

After half a dozen cuts I eventually found a small red tantalum capacitor that measured 0.7 ohm. I removed it and after fitting a modern equivalent, and soldering across the cut tracks, powered up and saw some red displays illuminated.
